TSB # 18-2021

SUBJECT: Improper “Baffle Plate” Positioning

Effective serial number range: model year 2021 - 7000, 8000 and 9000 series air-seeders equipped with ASC

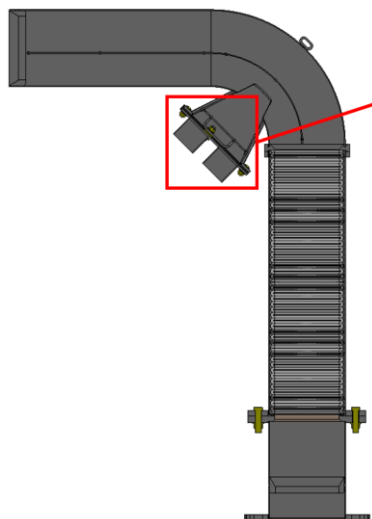
However If units are exhibiting the symptoms listed above it will be important to verify for the correct positioning of the “baffle plate”

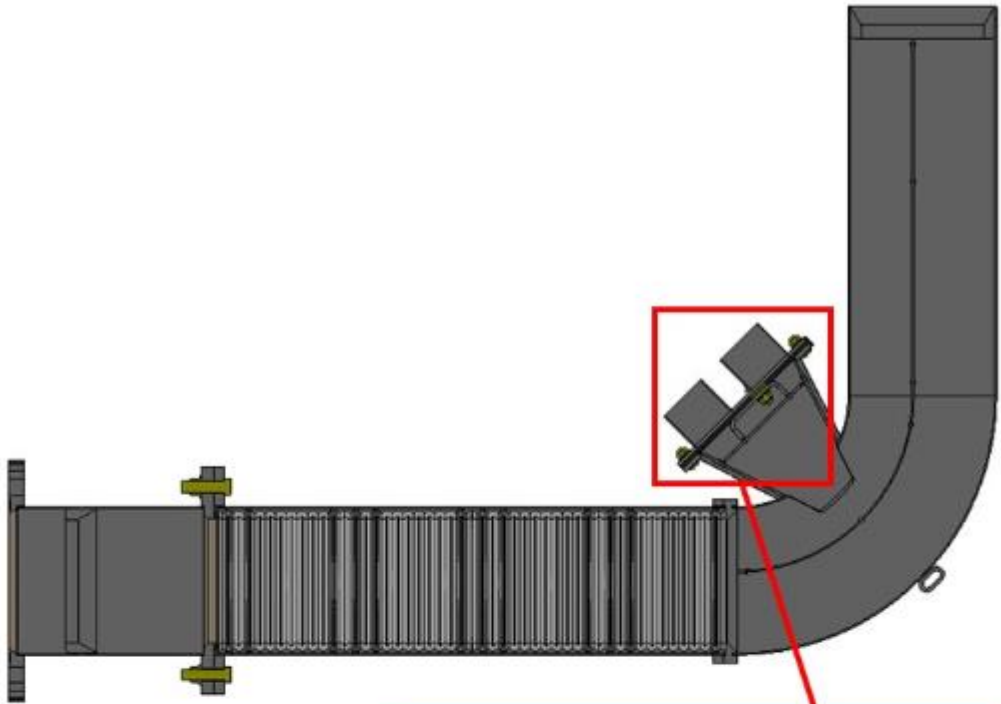
- The problems indicated above are the result of the baffle plate being tight against the plenum therefore restricting airflow
- To correct the problem perform the following steps

Gap Around Periphery of Baffle Plate to Plenum Body

- The baffle plate is bolted to the plenum cover
 - Remove the plenum cover
 - The baffle plate most likely has two washers (acting as spacers) between it and the plenum cover

- Remove one washer – re-assemble and inspect for proper gap
 - Remove the second washer if proper gap is not achieved
 - Once proper gap is achieved test for proper function

- Ensure 3/32" to 5/32" Gap**
- Remove one washer, re-assemble to verify gap.
 - Remove second washer if required.

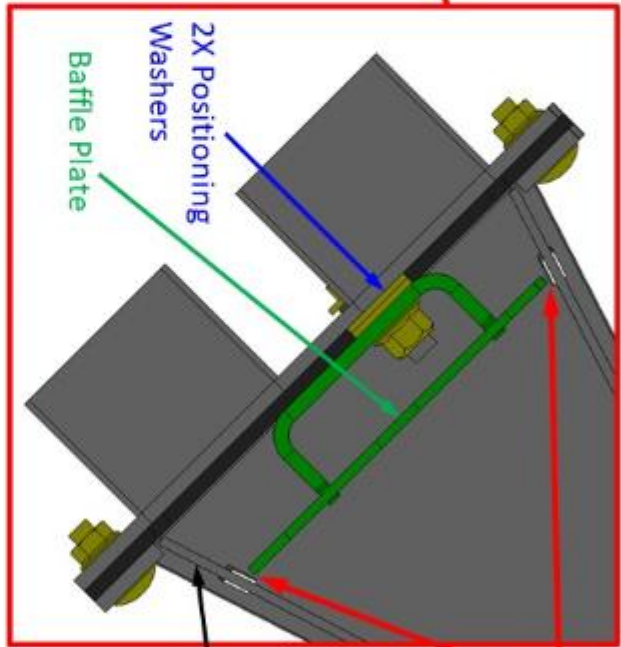
Gap is Visible Through Clean Air Port
