TO:
 ATTN:
 SUBJECT: HF Hitch Improvements for 3320 and 3720 drills

FIX ON FAILURE (Failure Code 21.19)

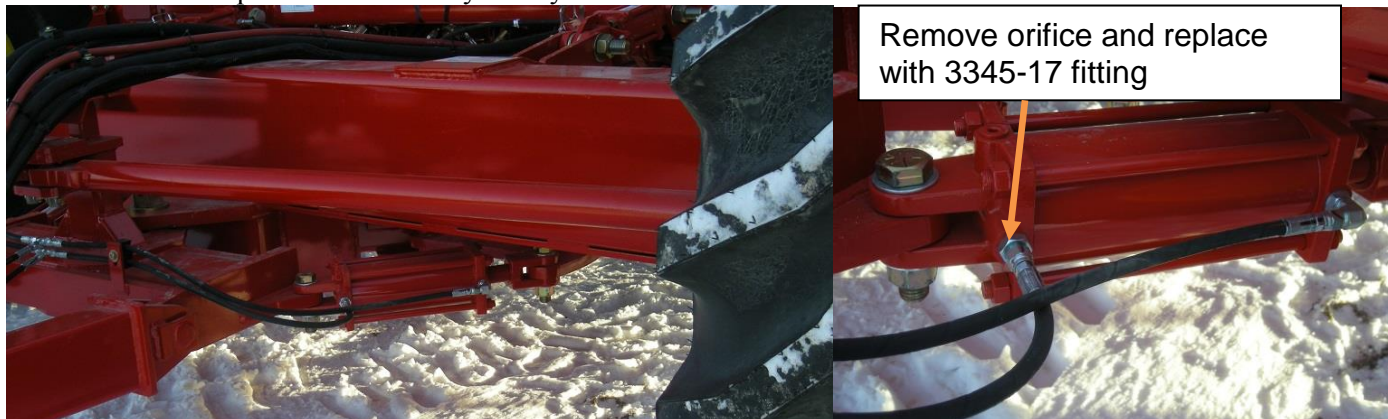
#1 - HF Cylinder – Orifice Removal

In the high floatation hitch design the hitch cylinders extend during opener operation to keep the hitch centered and prevent skewing or side-drafting and are retracted when the openers are raised to allow turns to be made. To prevent the depth circuit raise and lower times from being increased when using a HF hitch - orifices were added to the cylinders to sequence the oil to the lift circuit first thereby building a slight delay into cylinder retraction. Back in 2012 there were more tractors that were flow limited however today very few tractors used on 3320/3720 drills are flow limited. These orifices should be removed to prevent bending of the HF cylinders when negotiating quick/tight turns where the orifice will restrict how fast the oil can leave the cylinder and retract.

- Remove the orifice if present and replace with a standard fitting
- To confirm presence of orifice you may need to remove the hose and look for the 1/8” hole

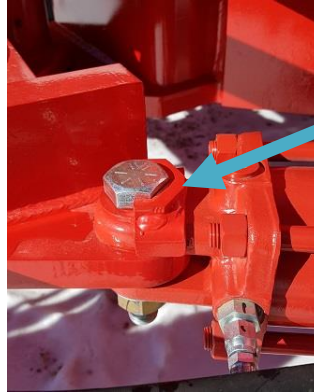
#2 - HF Cylinder – Change to Gr 8 bolts and anti-turns

The bolts that attach the HF cylinder to the rest of the hitch components have been upgraded to a GR8 bolt. The GR8 bolt has a longer shank that keeps threads out of the load bearing area and its “harder” material resists wear much better than a gr5 bolt. In addition to the gr8 bolt an anti-turn has been added to each bolt to prevent it from turning during normal hitch movement thereby preventing wear to the cylinder lugs.

Anti-turn
Base end of
cylinder shown

- Replace Gr5 bolts with Gr8 bolts and add the associated anti-turn device to each.

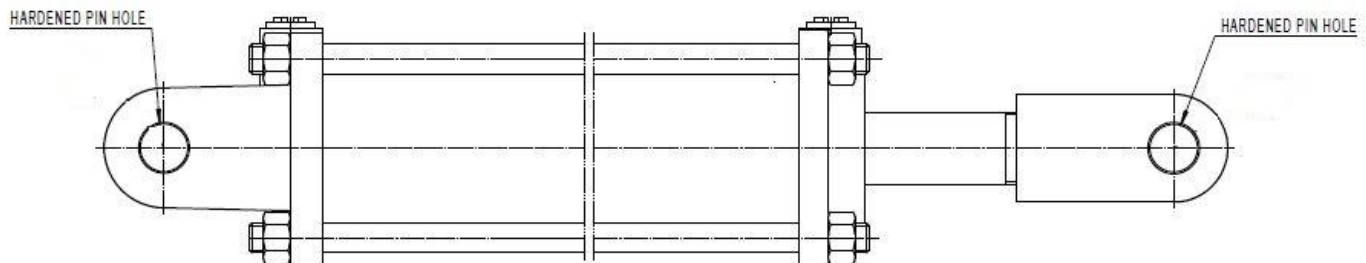
#3 - HF Cylinder – Change to cylinder with hardened clevises

To further improve durability and prevent wear in this HF hitch area the cylinder used now has hardened clevises. IF cylinder lugs show wear then the new style cylinder should be used in its place.

- Replace existing worn cylinders with ones with hardened clevises.

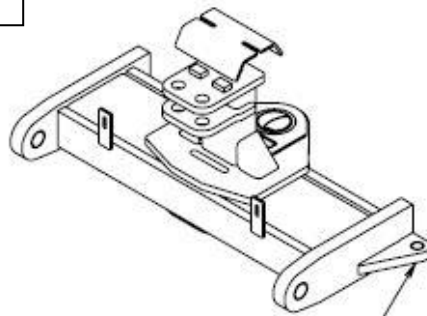
STEP 1

An area of concern is the lug to which the base end of each HF cylinder attaches. This lug is part of what we call the steering box. It is common to see significant wear or damage to the hole in this lug, therefore in order to achieve a lasting repair this lug must be replaced or the entire steering box replaced.

AFFECTED CYLINDER LUG

- Remove existing worn lugs and weld on the newer version made from QT 100 material which is much harder and resists wear and damage better than the original.

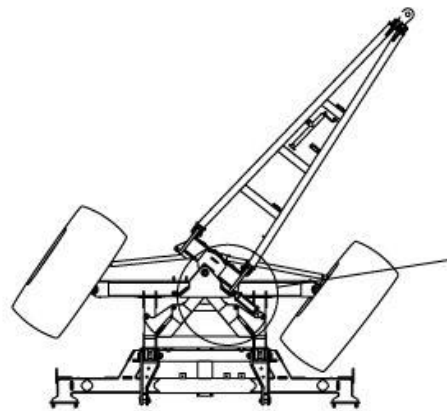
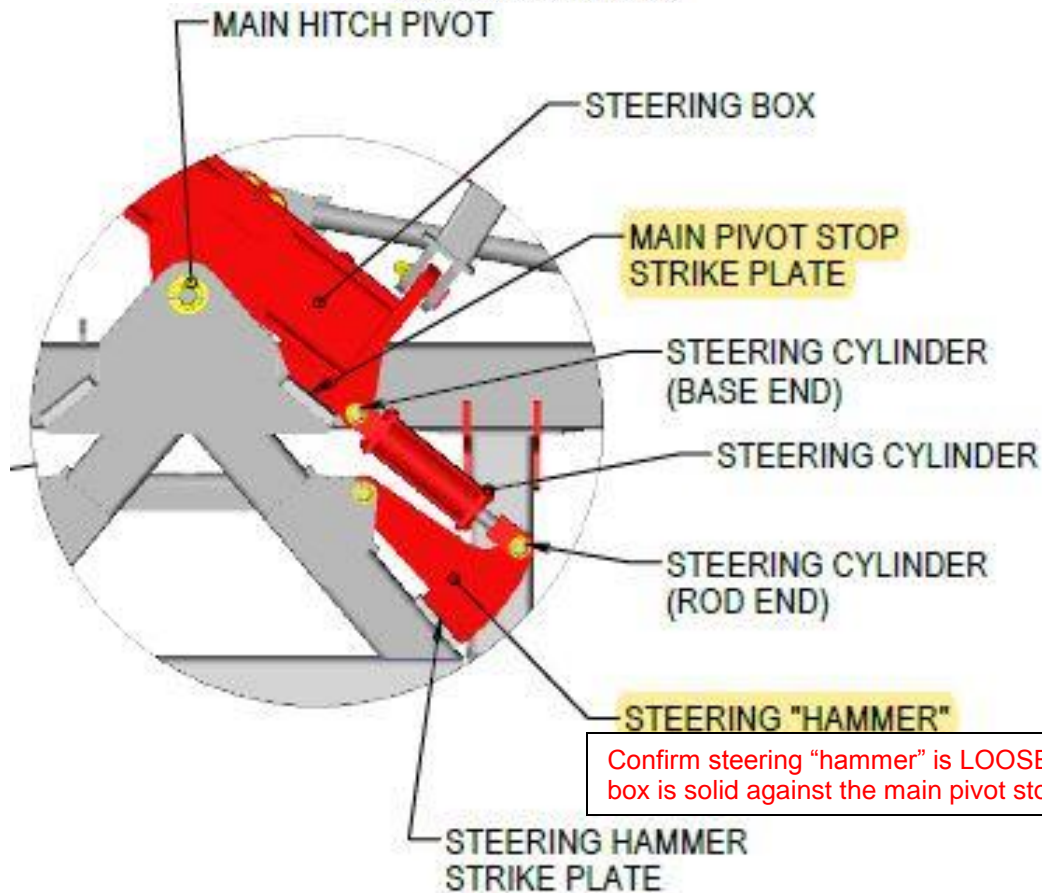
HIGH FLOTATION STEERING AS VIEWED FROM BELOW
 (HITCH IS FULLY ARTICULATED)

#5 - HF Cylinder – confirm HF cylinder is not crushed when hitch is fully articulated
CORRECTIVE ACTION:

- Due to the relatively high number of pivot points and the ability to have tolerances stack up it needs to be confirmed that the HF cylinder is not being crushed when the hitch is being fully articulated.
 - When the steering box is solid up against the **main pivot stop strike plate** the **steering hammer** needs to be “loose”
 - If the steering hammer is not loose then the cylinder clevis needs to be adjusted shorter to provide adequate clearance for the steering hammer
 - Adjust and repeat as required.

Confirm steering “hammer” is LOOSE when the steering box is solid against the main pivot stop strike plate

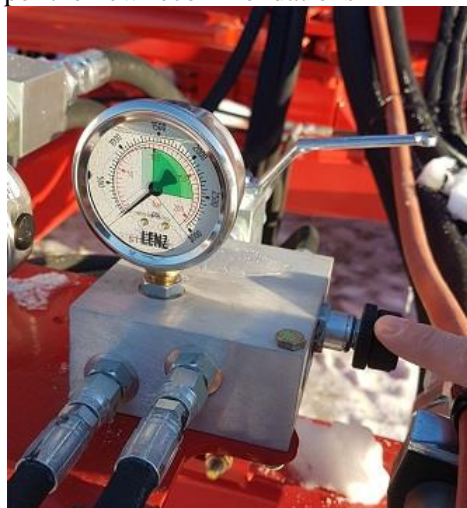
#6 - HF System Pressures – Lowering of the Initial break-out pressure settings

The HF hitch system utilizes a pressure relief valve to provide a “break-out” pressure when the HF cylinder is allowed to retract when making a corner while seeding. Seeding around the headland or perhaps around a power pole, rock pile or other obstruction is an example of this, furthermore it keeps the HF cylinders locked in the straight position up until this pressure is reached to keep the machine tracking directly behind the tractor, this is important on side-hills. Each size of machine has an initial pressure setting for which it is recommended to start. Investigation into these settings has revealed perhaps that our initial settings were on the high side of things for most operating conditions, therefore for model year 2019 the initial pressure settings have been reduced. For existing units it is recommended to “lower” the previously used pressures to the new recommendations – unless that is you have more extreme side-hill conditions where the higher pressures are required.

- Reduce operating pressures as per the new recommendations

Unit size	Pressure setting	
3320-60	1400psi	
3320-66	1600psi	
3320-76	1800psi	
3320-80	1900psi	before sn: 42773PH-01
3320-86	2000psi	before sn: 42773PH-01
3320-80	1500psi	after sn: 42773PH-01
3320-86	1500psi	after sn: 42773PH-01
3720-60	1400psi	
3720-70	1700psi

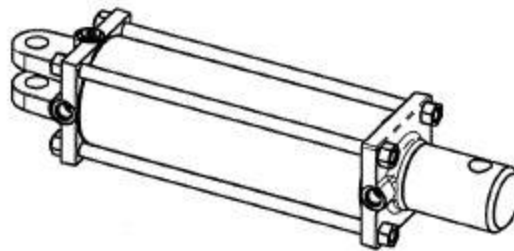
- 3320-86’ units built prior to sn: 42773PH-01 use many of the same components as what is listed in the previous pages and the areas of concern (#1 thru # 6) can be resolved as indicated on the previous pages.
- 3320-86’ units between sn: 42779PH-01 and sn: 43003PH-01 were built with a few differences
 - #1 – HF Cylinder – Orifice Removal - same as instruction indicated on previous pages.
 - #2 – HF Cylinder – Change to Gr 8 bolts and anti-turns - same as instruction indicated on previous pages but only applies to the base end of the cylinder since from new it used a Gr8 bolt and anti-turn device on the rod end.
 - #3 - HF Cylinder – Change to cylinder with hardened clevises - A different HF cylinder is used which has a “boss” style on the rod end.
