TSB # 28-2019

TO: All Bourgault Dealers
ATTN: Service Manager, Parts Manager, Sales Manager
SUBJECT: Incorrect Geometry on X30/X35 Monitors.

INFORMATION BULLETIN

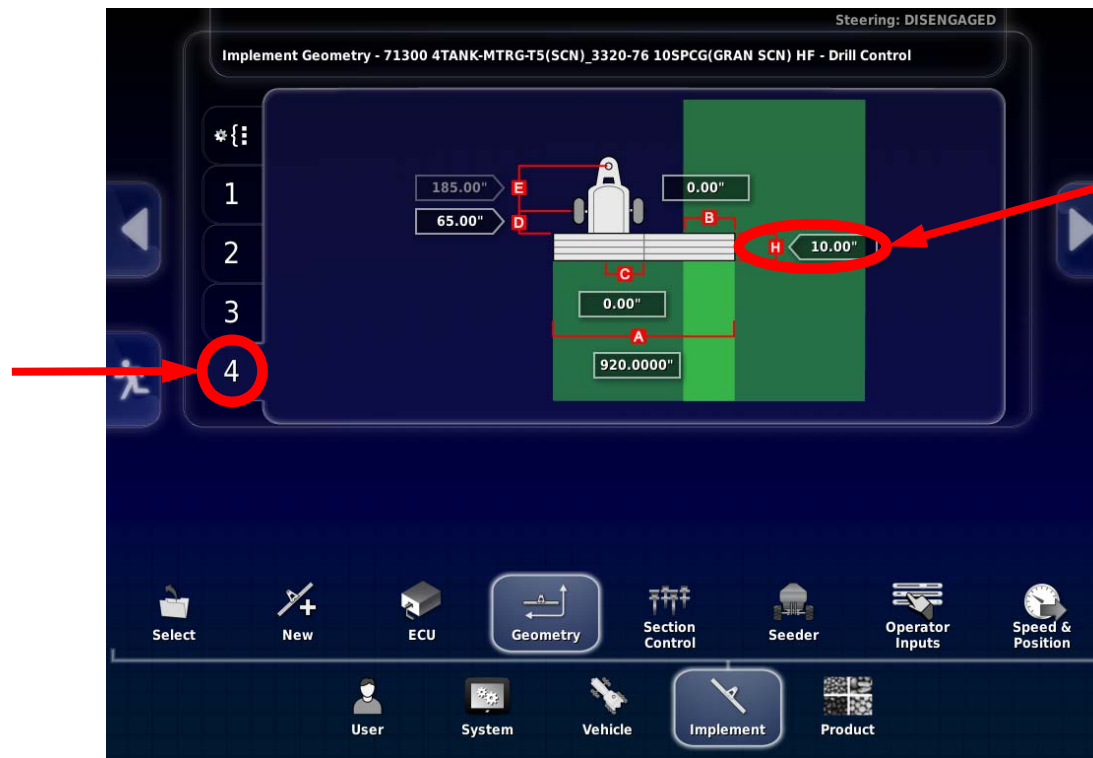
It has been discovered that the geometry in some of the factory profiles are incorrect. When the dual boom ASC software was developed for use in X30 and X35 monitors a mistake was made when creating the Drill Control geometry. This error will result in LIFTMASTER beginning to raise the openers too early – depending on seeding speed approximately 8-10ft.

DUAL BOOM PROFILES: Have an error in the 'Drill Control' Boom (Boom # 4)

- Follow the instructions on page 2 to correct the geometry.

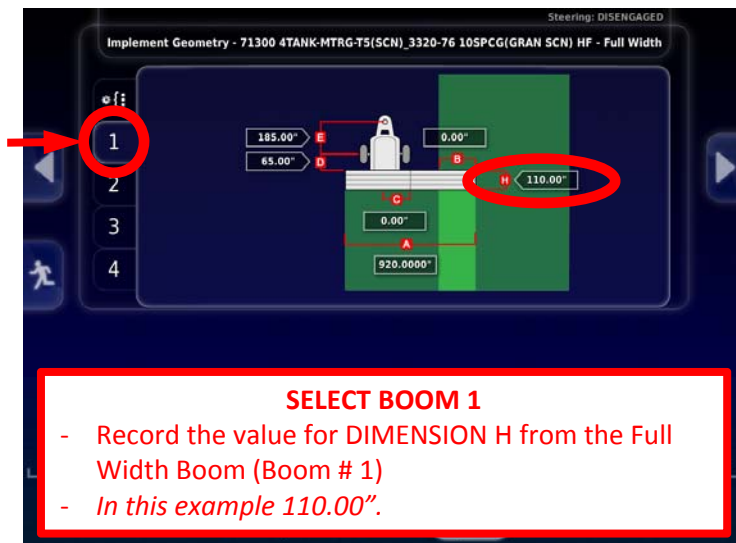
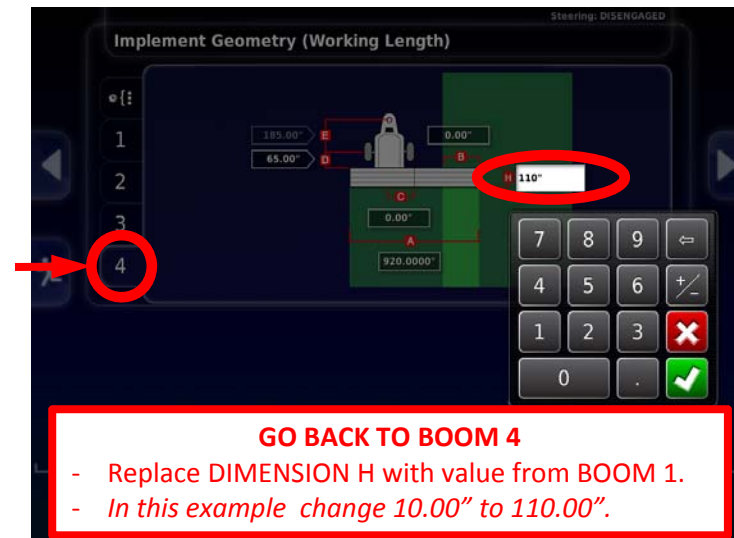
DIMENSION H (Working Length)
- is set at a value of 10.00" in the factory profiles.
