TSB # 7-2020

TO: All Bourgault Dealers
ATTN: Service Manager, Parts Manager, Sales Manager
SUBJECT: 3710 – Pivot Arm Bearing Retrofit Kits – Special Pricing for 2020

INFORMATION BULLETIN (Information code 7.20)

Effective Serial Number Range – 3710 ICD drills with opener versions (A, B or C).

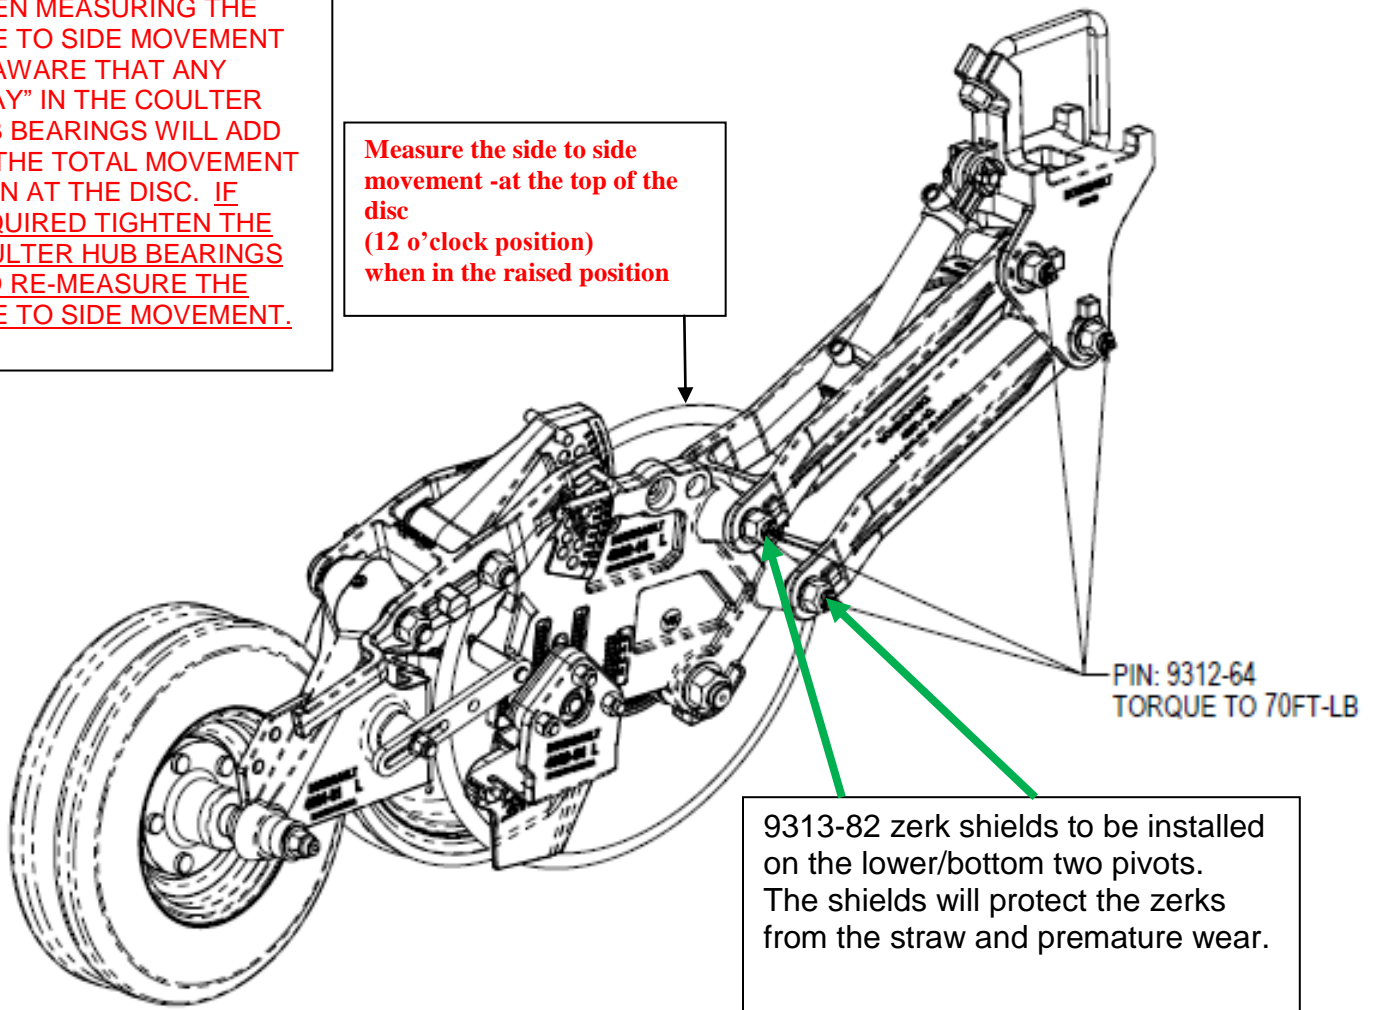
IMPORTANT NOTE:
WHEN MEASURING THE SIDE TO SIDE MOVEMENT BE AWARE THAT ANY "PLAY" IN THE COULTER HUB BEARINGS WILL ADD TO THE TOTAL MOVEMENT SEEN AT THE DISC. IF REQUIRED TIGHTEN THE COULTER HUB BEARINGS AND RE-MEASURE THE SIDE TO SIDE MOVEMENT.

Measure the side to side movement -at the top of the disc
(12 o'clock position)
when in the raised position

3710 opener – showing 4 greaseable pin locations

- It is recommended that parallel arm pivot bushings showing 1/4” of “side to side” movement, as measured at the top of the disc when in the raised position, be repaired to avoid potential performance problems.
