TO: All Bourgault Dealers
ATTN: Service Manager, Parts Manager, Sales Manager
SUBJECT: 7550/L7550 Auger Lift Blocks

FIX ON FAILURE (Failure Code 14.18)

Effective serial number range: 7550 and L7550 built prior to Jan 2018

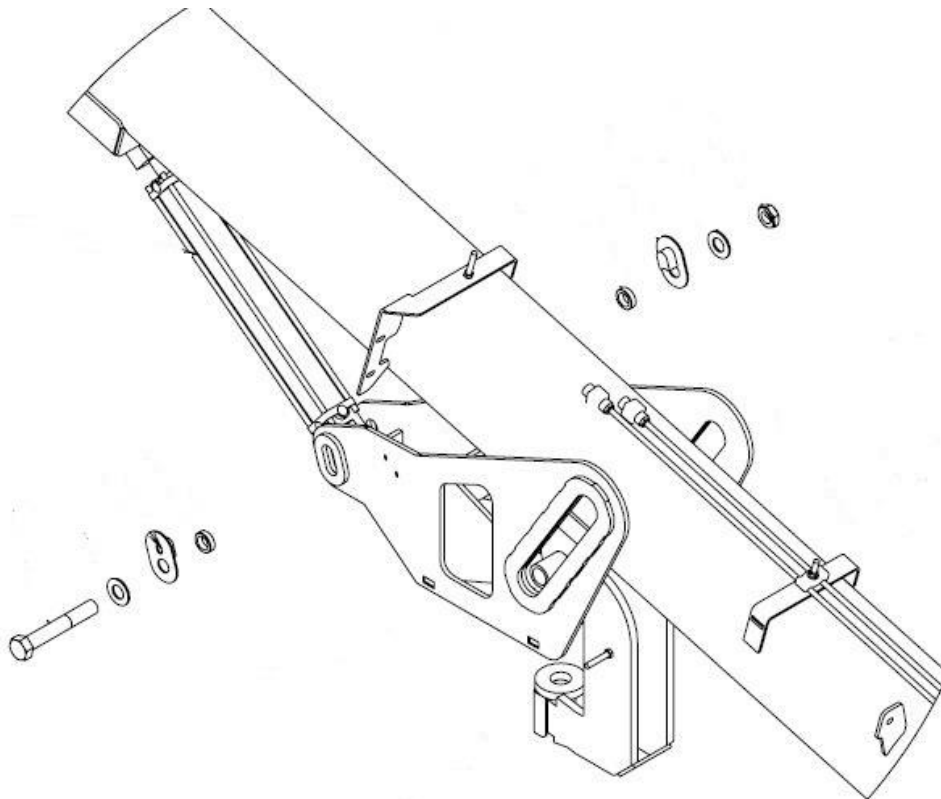
7550's and L7550's equipped with the deluxe auger may encounter difficulty lifting the auger high enough to clear the auger saddles. Due to a stack-up of tolerances in the various components the lift cylinder simply cannot lift the auger high enough to clear the saddles. Stop blocks have been designed to be inserted into the lift cylinder slot and allowing the auger to be lifted higher and clear the saddles. Units that encounter this problem can be upgraded by adding the parts listed in the table below.

- Remove the existing cylinder bolt
- Install the stop blocks and associated items to keep the cylinder bolt at the bottom of the slot
- Minor adjustments may need to be made to the auger saddle height after stop block installation.
 - Refer to the service and maintenance section of the operators manual for specific details
