TSB # 15-2017

March 2, 2017

TO: All Bourgault Dealers  
ATTN: Service Manager, Parts Manager, Sales Manager  
SUBJECT: "Rapid Opener Drop" – change to Counter-Balance Cartridge

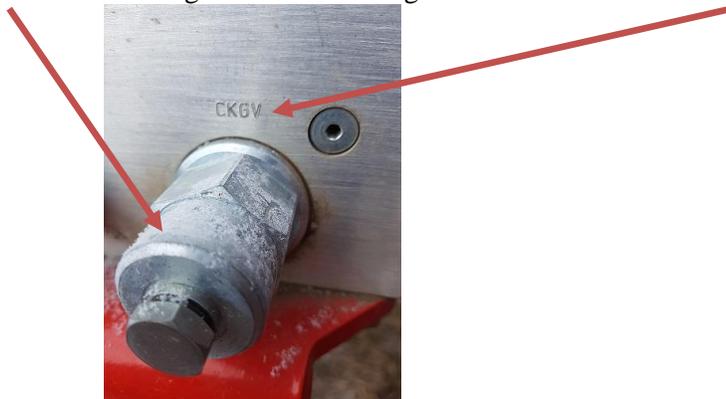
- The root cause of the rapid opener drop is the direct result of bypass within the opener cylinders combined with a significant amount of air retained in the system. The air combined with the bypass oil creates an imbalance within the system resulting in the PO check-valve being forced open and allows the openers to rapidly lower to the ground.

- Remove the existing PO Check-Valve cartridge from the existing block. The block will be stamped CKGV.
