TSB # 18-2021

SUBJECT: Improper “Baffle Plate” Positioning

Effective serial number range: model year 2021 - 7000, 8000 and 9000 series air-seeders equipped with ASC

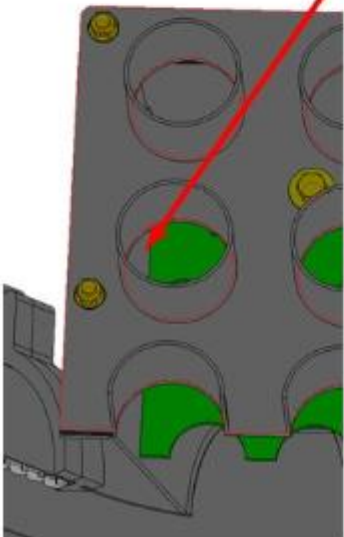
Gap is Visible Through Clean Air Port

- Ensure 3/32" to 5/32" Gap**
- Remove one washer, re-assemble to verify gap.
 - Remove second washer if required.
