# Bourgault Air Seeder--Chickpea Seeding

Bourgault Industries provided an air cart/air delivery system to determine operating parameters that will minimize chickpea damage.

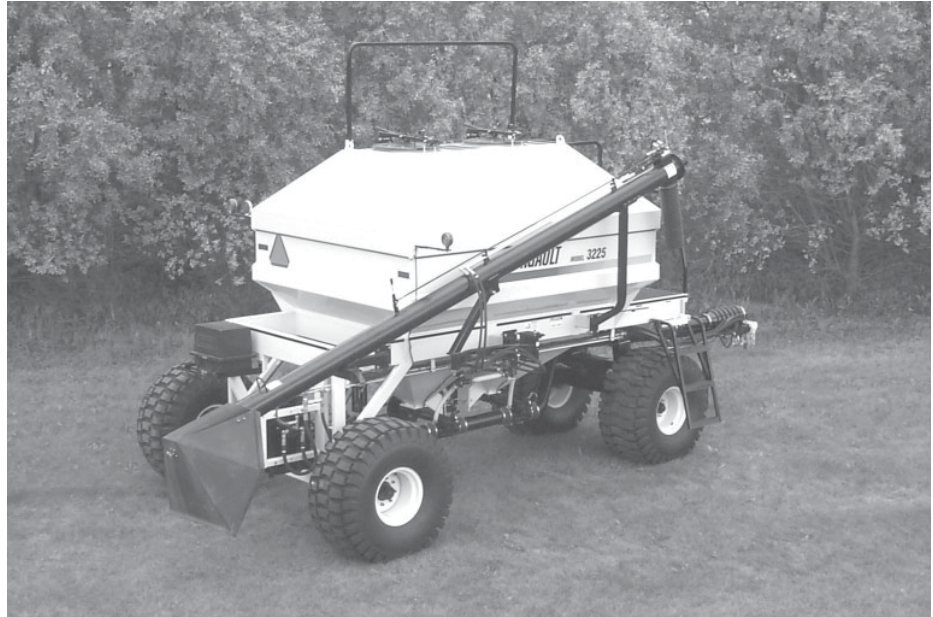
A Bourgault 3225 air cart with a PDM metering system and air kit with 5 Quick Inspection manifolds and 50 outlets was used for the test. The air kit was designed for a 40.8 ft (12.4 m) air drill with 9.8 in (25 cm) row spacing.
